Stryker...

PUT A STOP TO BRAKE DRUM STRIPPING!

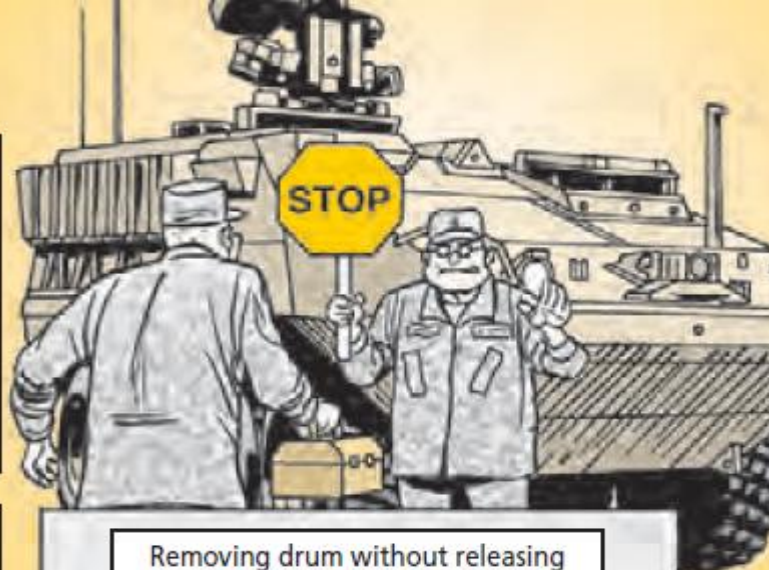
Recently, we've received reports that some Stryker brake drums are having to be replaced because of stripped jack bolt holes. Jack bolts are used to help remove the drum during PMCS inspection when it's stuck in place.

One possibility for the stripped holes is that technicians may be trying to remove the drum without first releasing the brake shoes. The brake drum replacement procedures in the IETM are being revised to make this requirement a little more clear.

Removing drum without releasing
brake pads could strip jack bolt holes

Until that happens, can you remind them that the brake shoes should always be released before trying to remove the brake drum?
